Radon in Air Testing Report

2018/2019

Red Deer Catholic Regional Schools

Red Deer Catholic Regional Schools 2018/2019

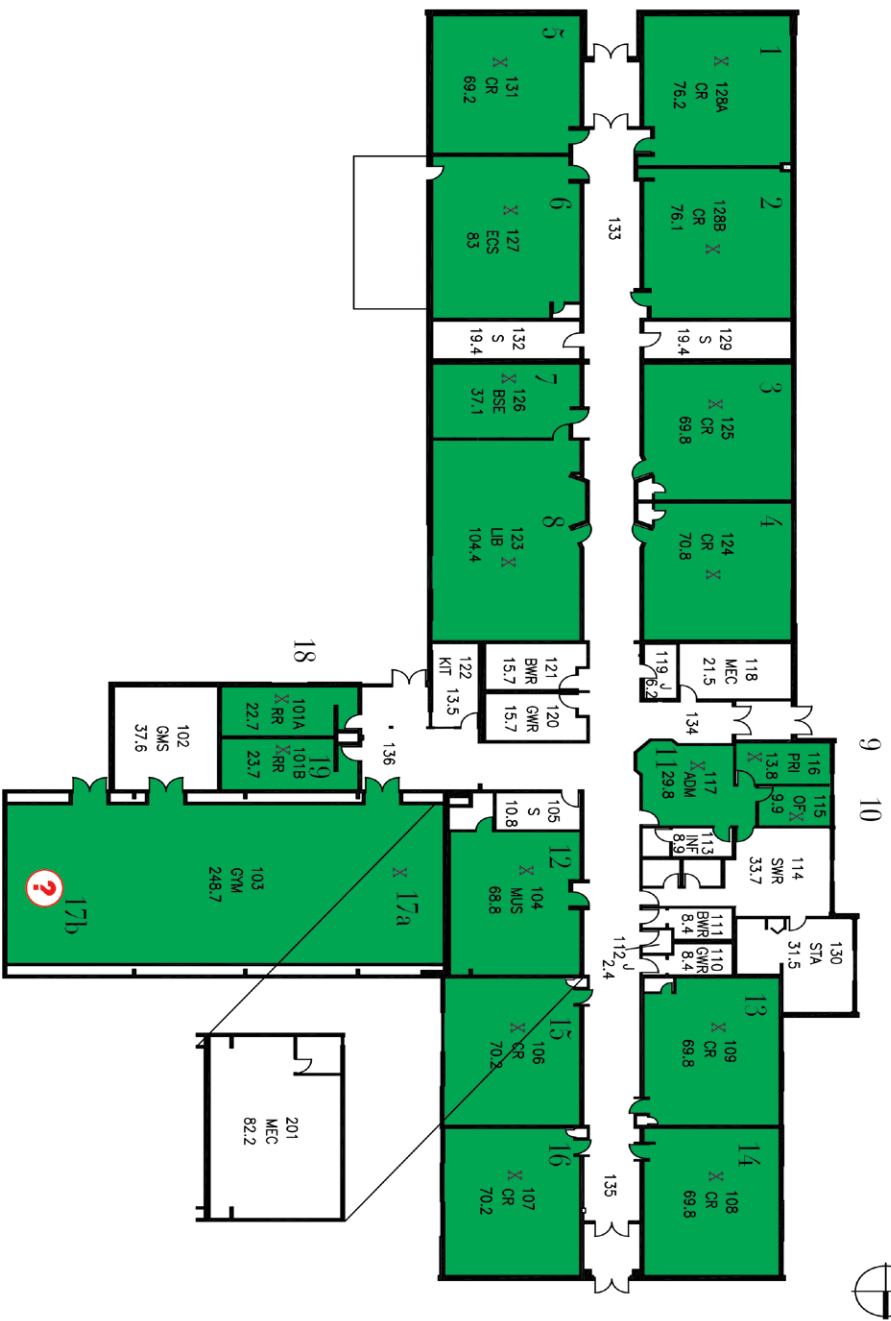
MARYVIEW ELEMENTARY SCHOOL

Table 3.6 **Maryview**

Long term radon sampling of selected rooms in Maryview School were well below both Health Canada and World Health Organization action level guidelines.

Sampling completed from December 26 2018 to April 14 2019 indicate measured levels are below guidelines and no corrective action is necessary at this time.

RadonCare recommends re-sampling if extensive construction or significant HVAC system changes are completed and after a period not exceeding 5 years from the completion of this survey.

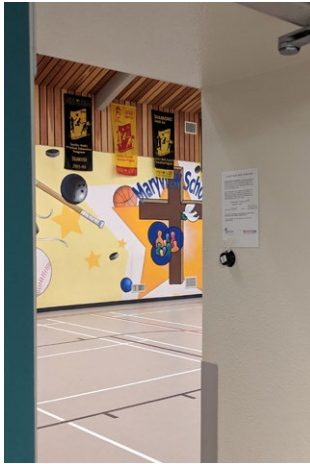
Dosimeter 17B-103-3912268 fell or was removed. Located and recovered taped to placard at gymnasium entrance.
